## TIA Inspection Report

Site Name Ellsworth ME

SC # 200435

Date of Inspection 12/14/20

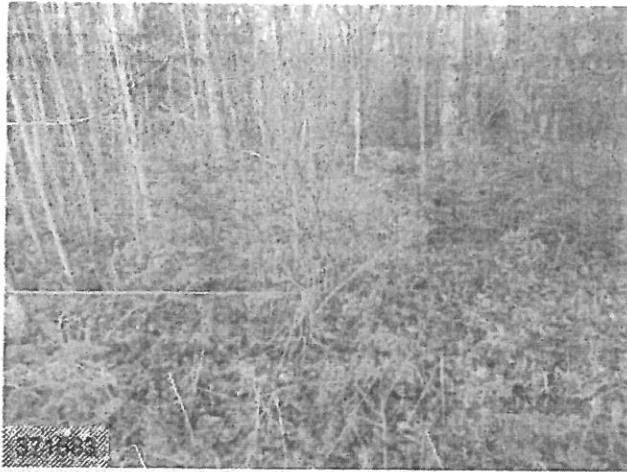
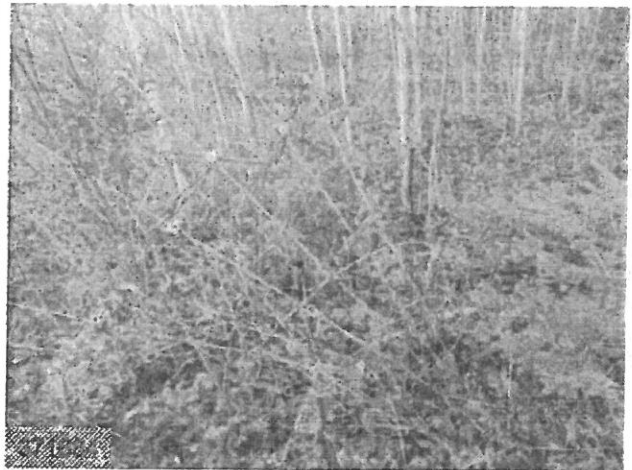
Anchor Compounds - Description

| Site Deficiency | Condition | Description | Repair Description |
|---|---|---|---|
| Anchor Compounds | Non-Critical<br>Repair | No anchor fences installed, no established anchor compounds<br>Vegetation encroaching on anchors | Clear vegetation around anchor heads. |

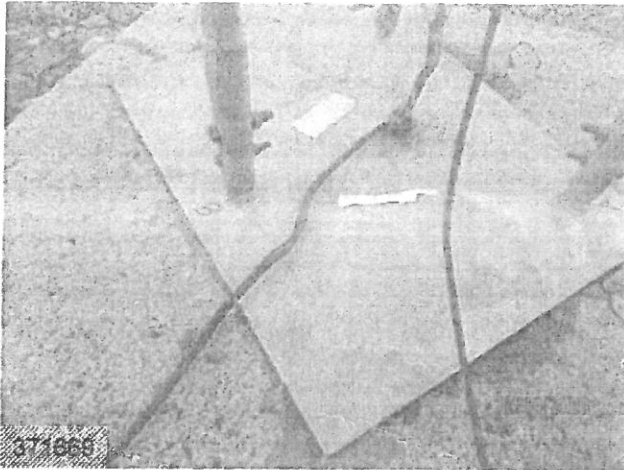
Weep Holes at Base - Description

| Item | Condition | Description | Repair Description |
|---|---|---|---|
| Weep Holes at Base | Moderate Repair | No weep holes at tower base. | Install weep holes at base of tower on all tower legs. |

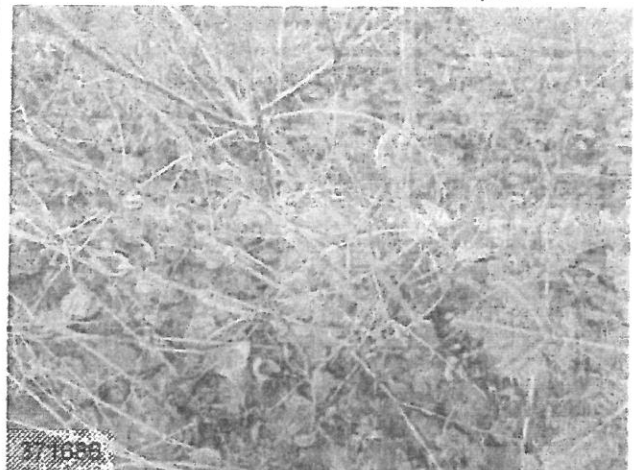
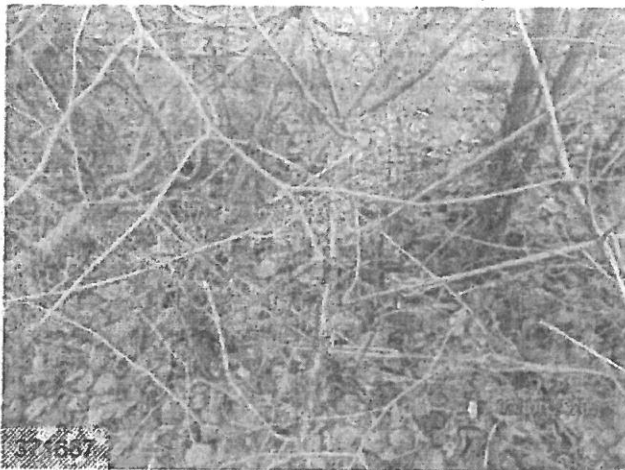
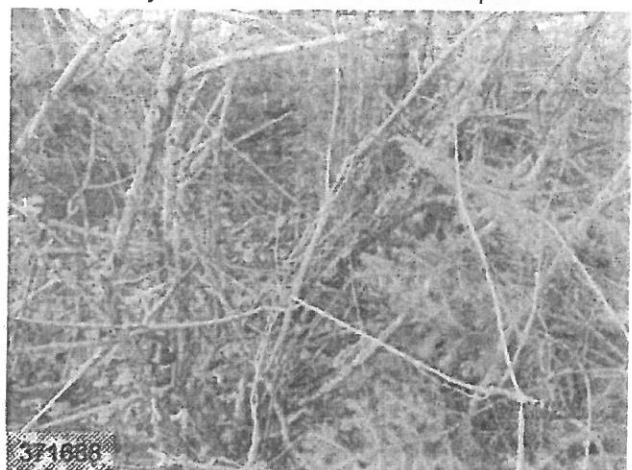
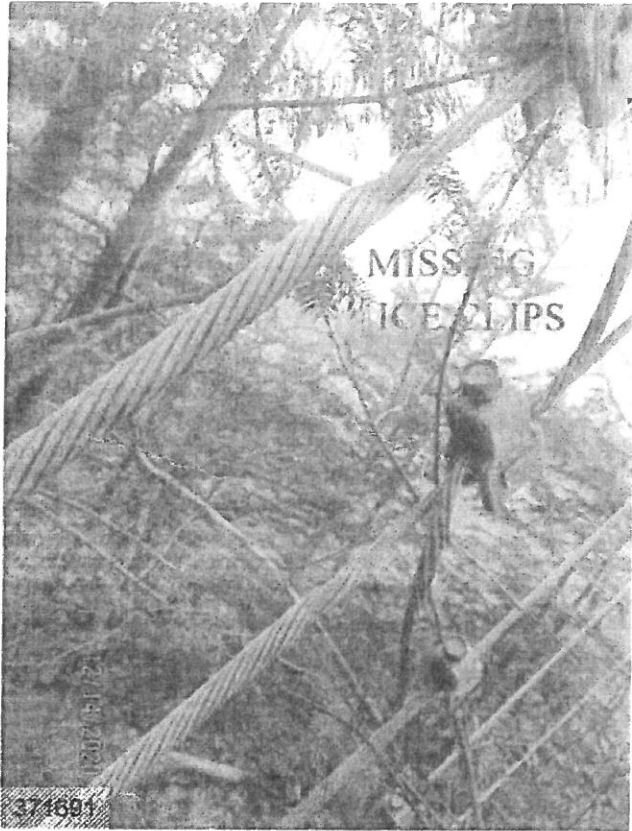
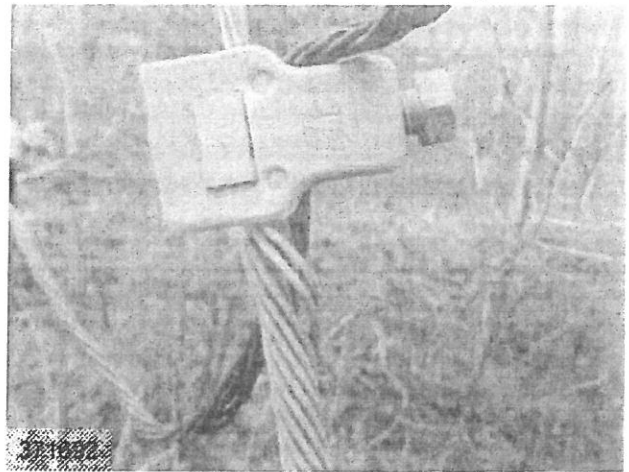
Guy Anchors & Hardware - Description

| Item | Condition | Description | Repair Description |
|---|---|---|---|
| Guy Anchors & Hardware | Moderate Repair | *Soil & leaf litter build-up - all anchor heads<br>*Vegetation/branches encroaching on anchors/hardware & guy wires<br>*No ice clips - all guy wires<br>*Wire A4 preform damaged | *Clear vegetation & regrade around anchor heads<br>*Install ice clips on all preforms.<br>*Remove and replace wire A4 preform. |

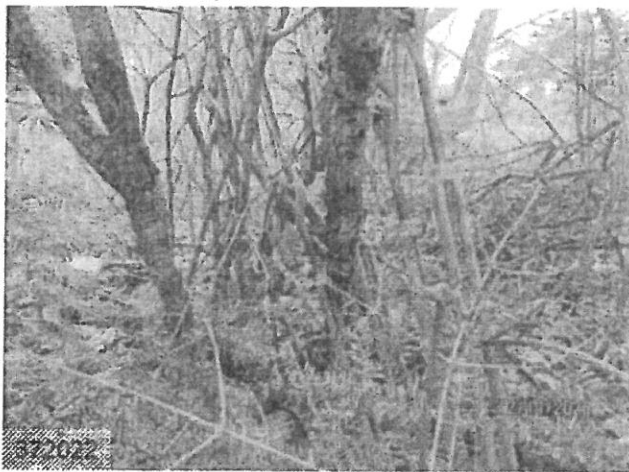
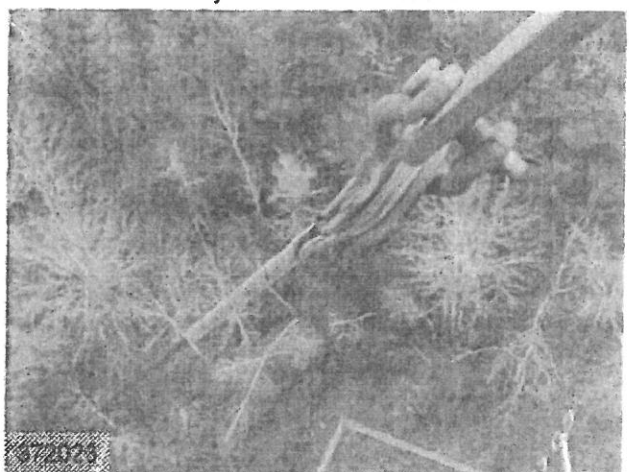
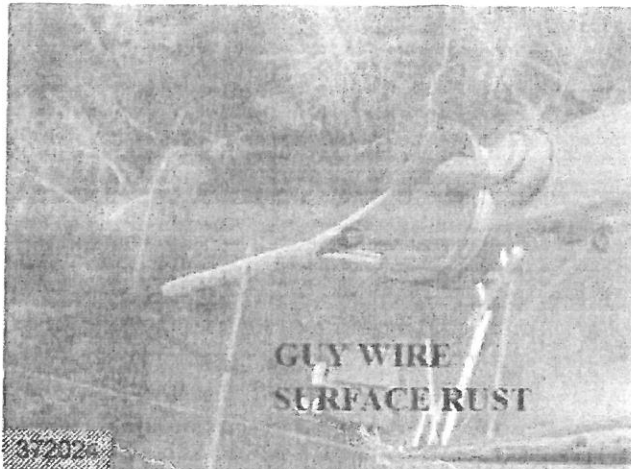
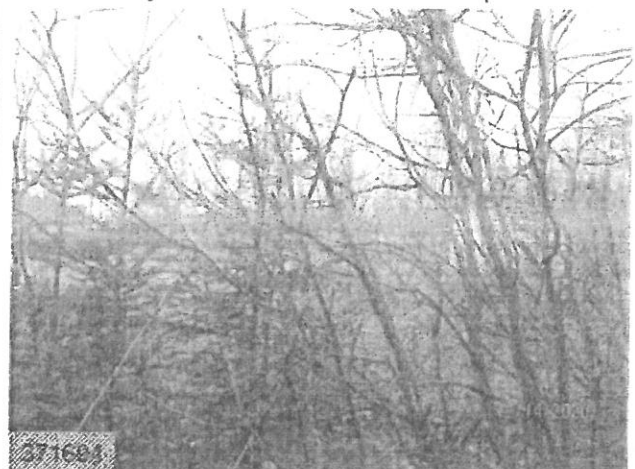
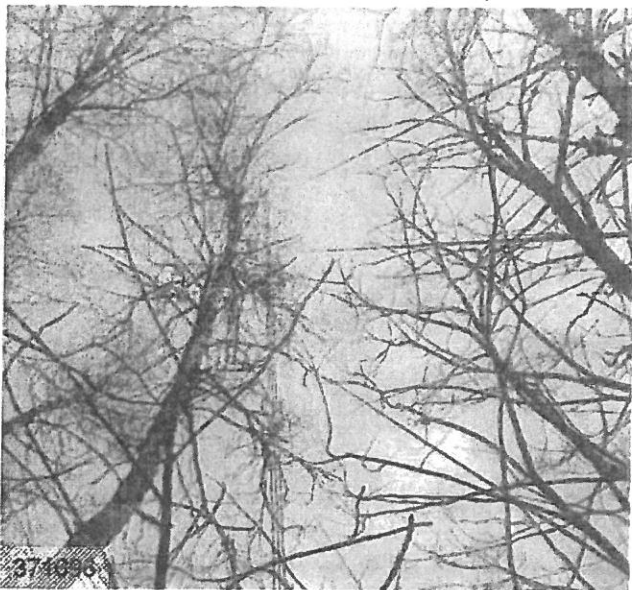
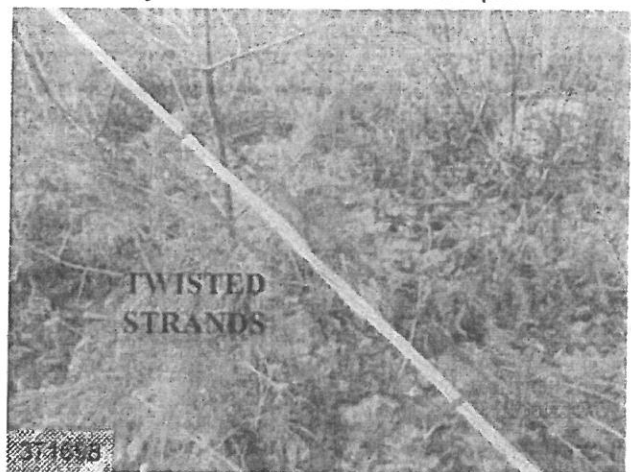
| Item | Condition | Description | Repair Description |
|---|---|---|---|
| Guy Wires & Obstructions | Moderate Repair | *Vegetation in contact with guy wires near anchors<br>*Deteriorated galv with 100% Surface rust on G4 and G5 wires at tower side.<br>*Irregularly twisted (criss-crossed) guy strands on A1 and A2. | *Clear vegetation from all guy paths near anchors<br>*Recommend replacing G4 & G5 wires soon due to small wire strand size<br>*Recommend replacing A1 & A2 wires due to twisted strands |

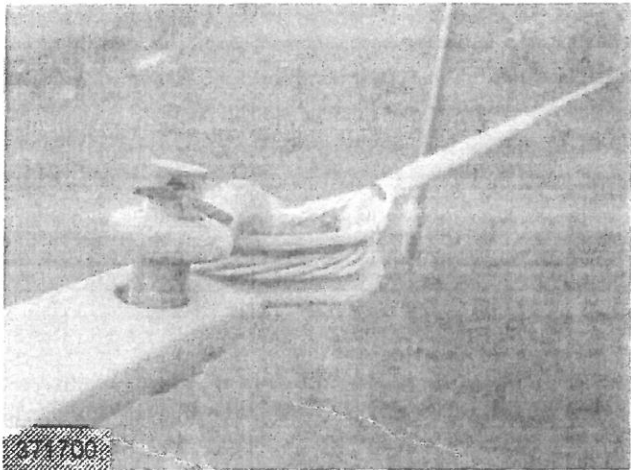
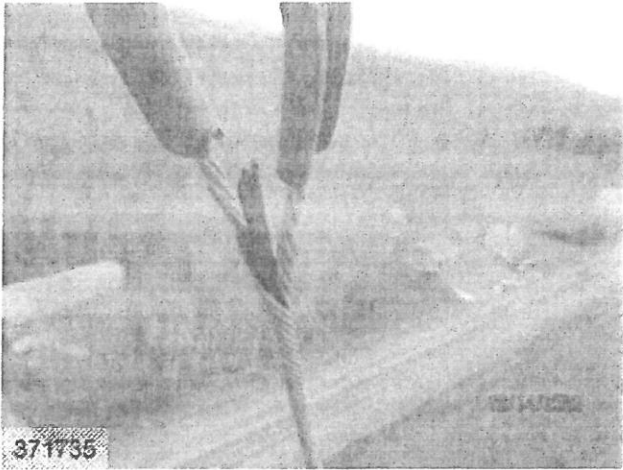
| <p>Guy Attachments at Tower - Description</p> <p>371706</p> | <p>Guy Attachments at Tower - Description</p> <p>371735</p> |

| Item | Condition | Description | Repair Description |
|---|---|---|---|
| Guy Attachments at Tower | Moderate Repair | *Heavily rusted cotter pins at all guy elevations.<br>*No seizing on guy tails | Install seizing wire at all guy attachments. Replace rusted cotter pins. |

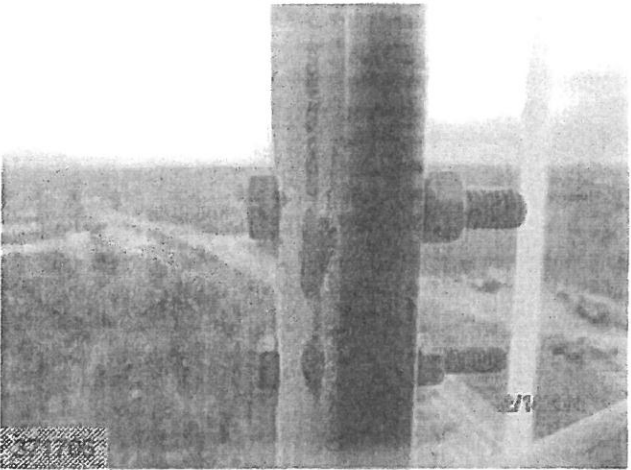
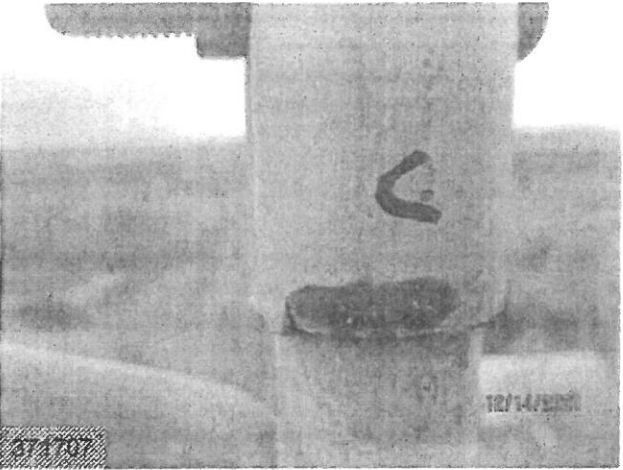
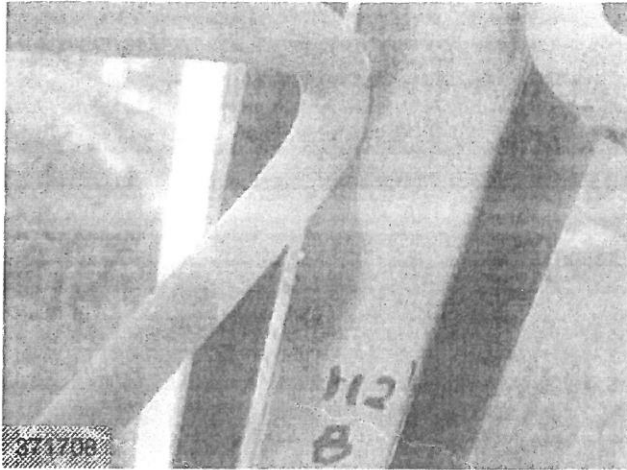
Tower Members - Description

| Item | Condition | Description | Repair Description |
|---|---|---|---|
| Tower Members | Non-Critical Repair | Small areas of chipped galv with surface rust | Clean areas of corrosion and apply (2) coats of ZRC cold galvanization compound. |

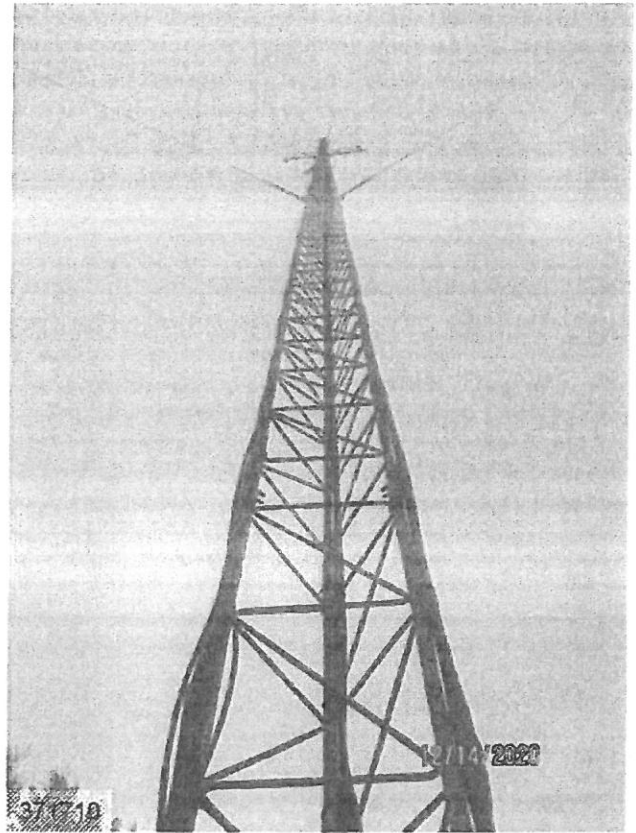
Safety Climb & Ladder/Pegs - Description

| Item | Condition | Description | Repair Description |
|---|---|---|---|
| Safety Climb & Ladder/Pegs | N/A | No Safety Climb System present on tower. | Install new Safety Climb System on tower. |

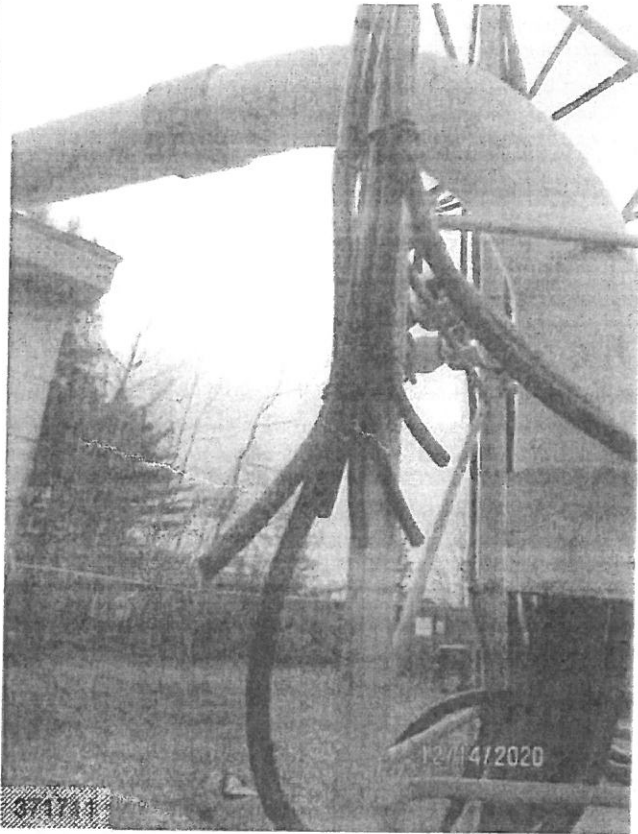
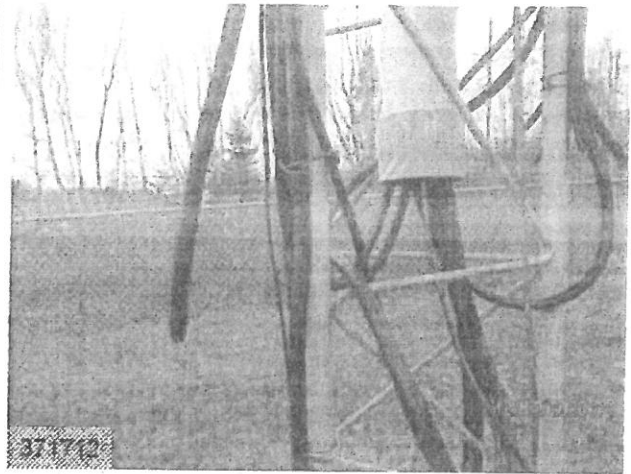
Transmission Lines - Description

| Item | Condition | Description | Repair Description |
|---|---|---|---|
| Transmission Lines | Non-Critical Repair | Several dead coax present on tower. | Remove unused/dead coax from tower to reduce loading. |

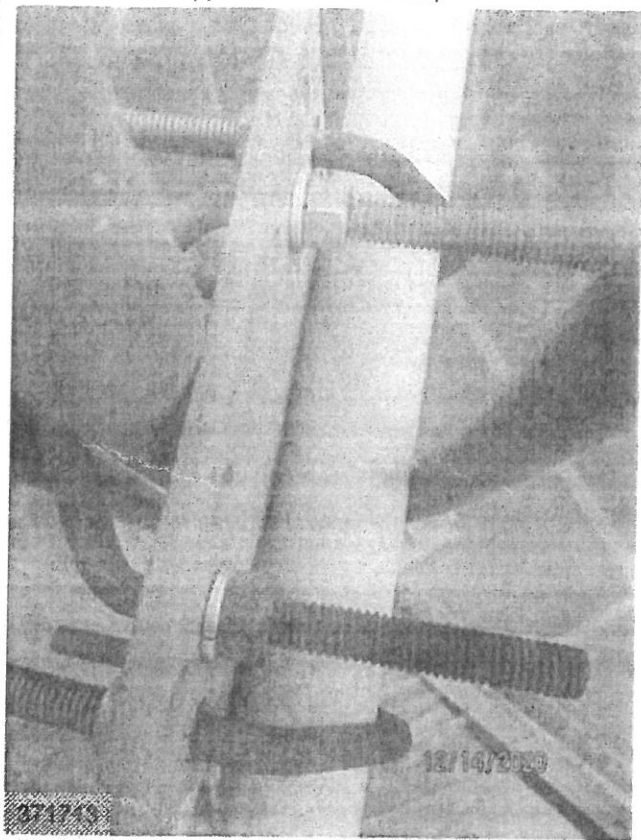
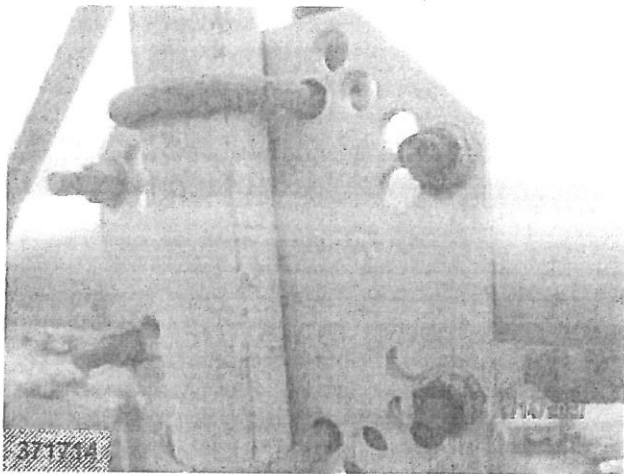
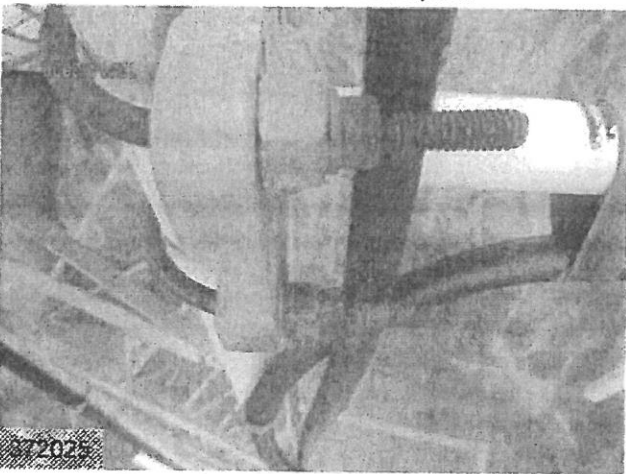
Appurtenances - Description

| Item | Condition | Description | Repair Description |
|---|---|---|---|
| Appurtenances | Non-Critical Repair | Initial corrosion on appurtenance mounting hardware throughout tower.<br>Some hardware with initial pitting | Remove areas of corrosion and apply (2) coats of ZRC cold galvanization compound.<br>Some of the worst hardware may need to be replaced |

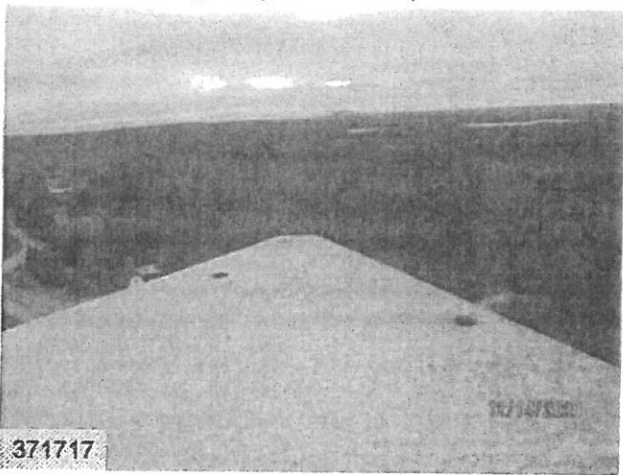
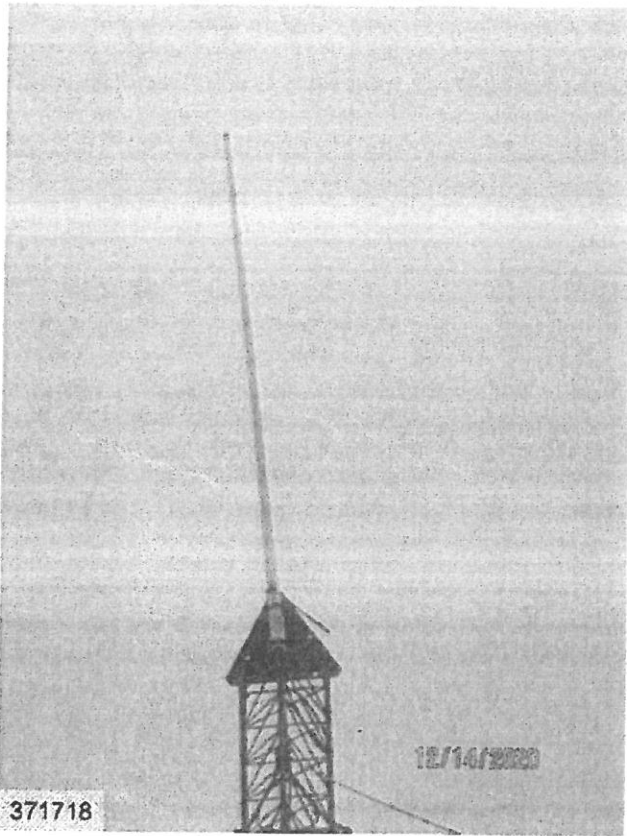
Lightning Rod - Description

| Item | Condition | Description | Repair Description |
|---|---|---|---|
| Lightning Rod | Non-Critical Repair | No lightning rod present on tower. | Recommend installing lightning rod to a height that exceeds all other appurtenances on tower. |
